Manhole Inspection Summary

Manhole # S25CC_029MH

Insp Date: **8/20/07 11:45 AM**

Location Address: **1117 CARROLLTON AVE**

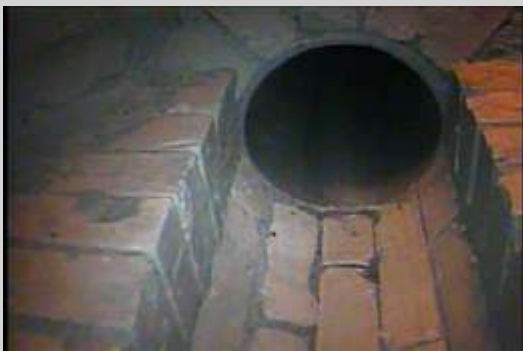
6 O'Clock Inflow

8 in. Circular Gravity Sewer
Pipe In @ 6 O'Clock

Pipe Height: **8.4** (in.) Rod and Bar (Angled)
Pipe Material: **Clay** ☐ Pipe Lined
Invert Depth: **7.14** (ft.) Flow Characteristics: **Slow**
Deposits: ☒ None ☐ Mud ☐ Sludge ☐ Debris ☐ Grease
Silt Depth: (in.) Deposits Extent:
Infiltration: **None** Pipe Seal Cond: **Sound**

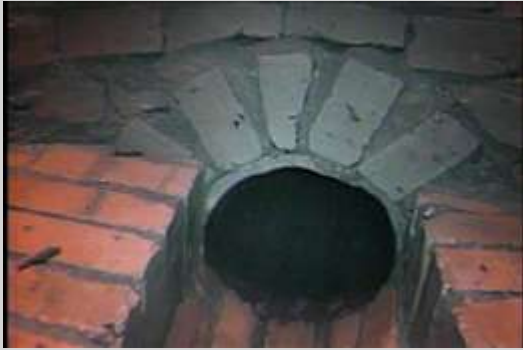
9 O'Clock Inflow

8 in. Circular Gravity Sewer

Pipe In @ 9 O'Clock

Infiltration: **None** Pipe Seal Cond: **Sound**
